Avalanche Details

- **Date:** 03 April 2016
- **Time:** 3:00 pm AST
- **Location:** Hoodoo Mountains, Eastern Alaska Range
- **Accident Site Coordinates:** 63.222883° N 145.320565° W
- **State:** Alaska
- **Reporting Agency:** Eastern Alaska Range Avalanche Center
- **Fatalities:** 1

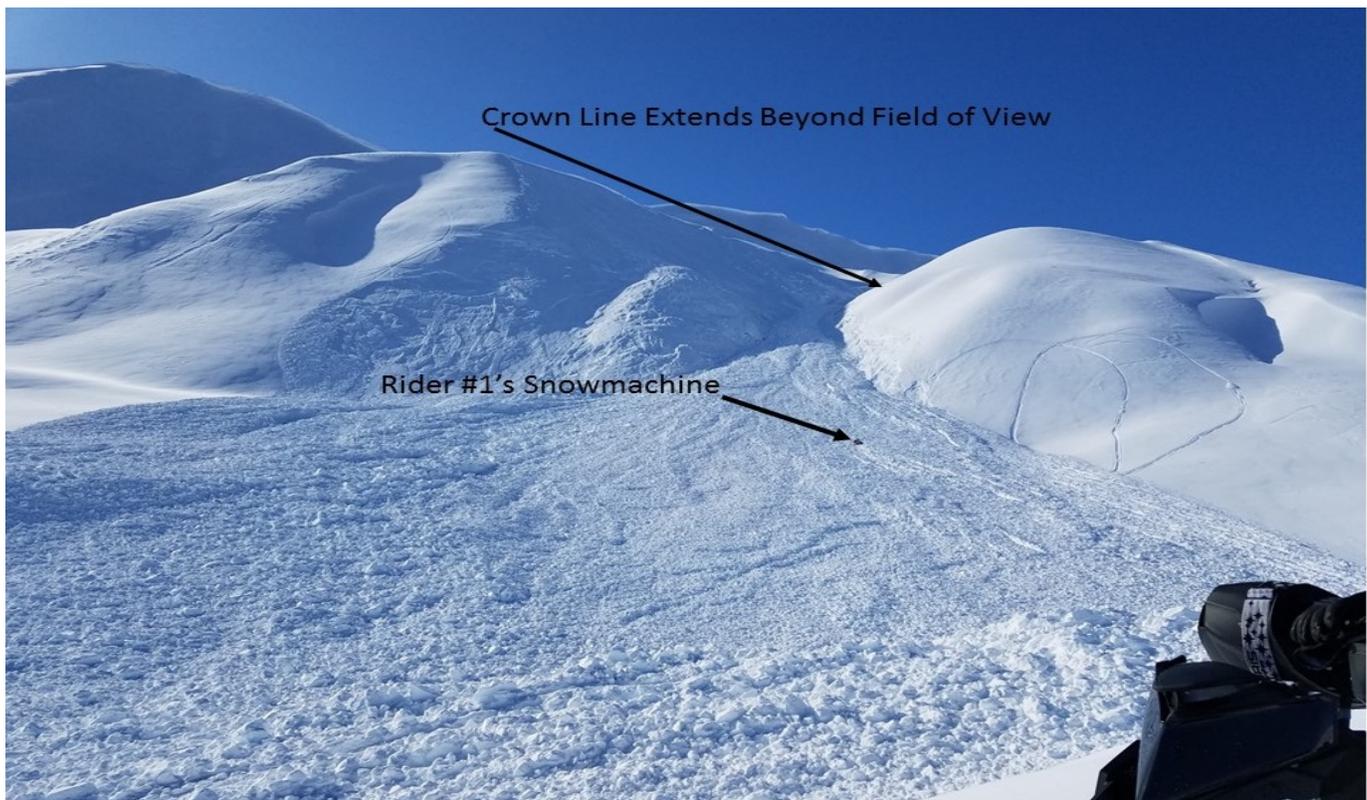
Figure 1: Accident site photographed from below. Shows extent of crown line & Rider #1's snowmachine.

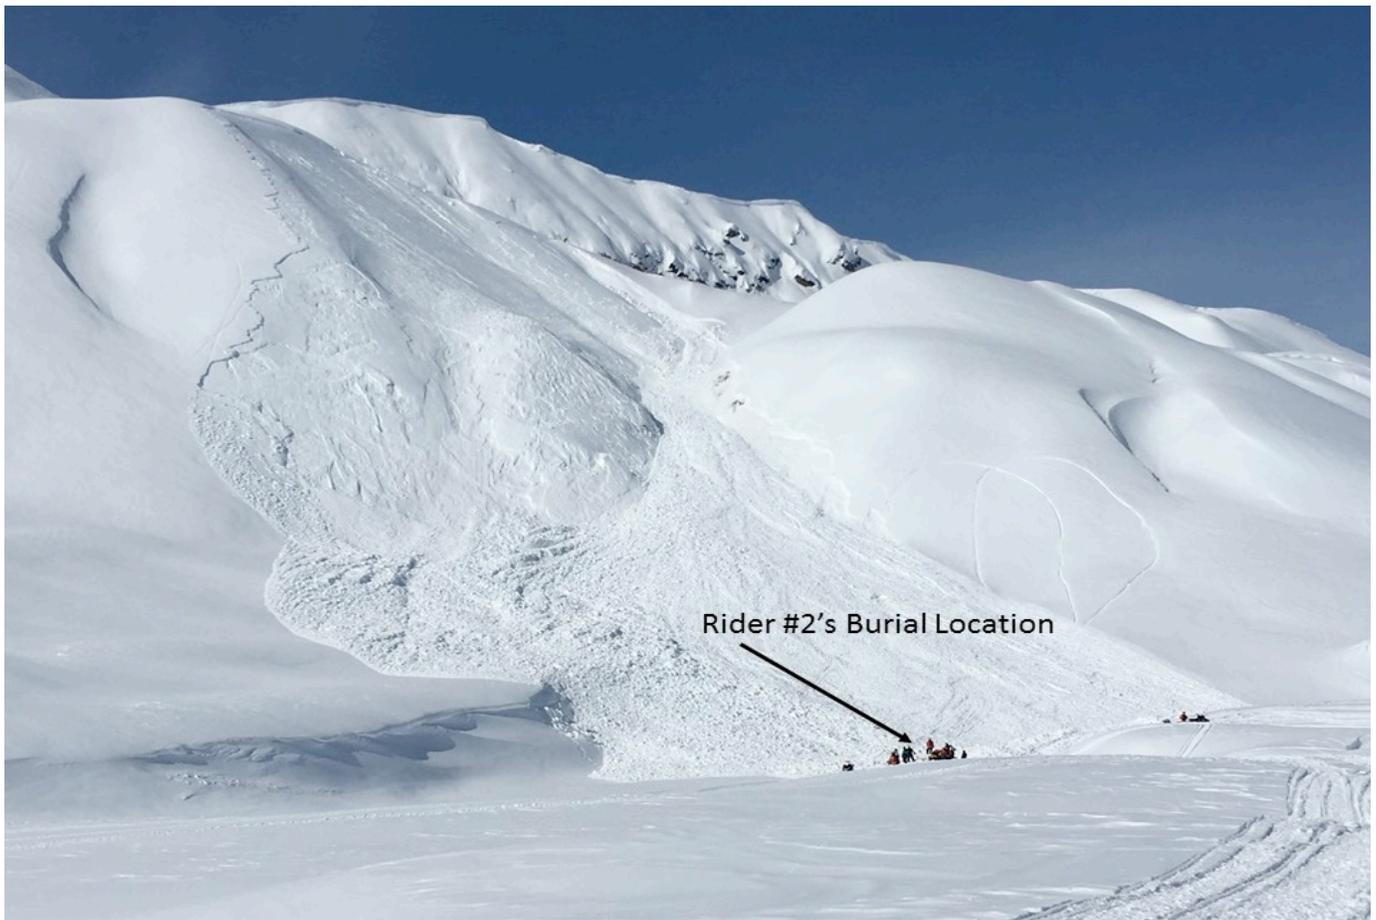
Figure 2: Photo Credit Matt Kennedy. Photo of the extent of the avalanche with Rider #2's burial location.

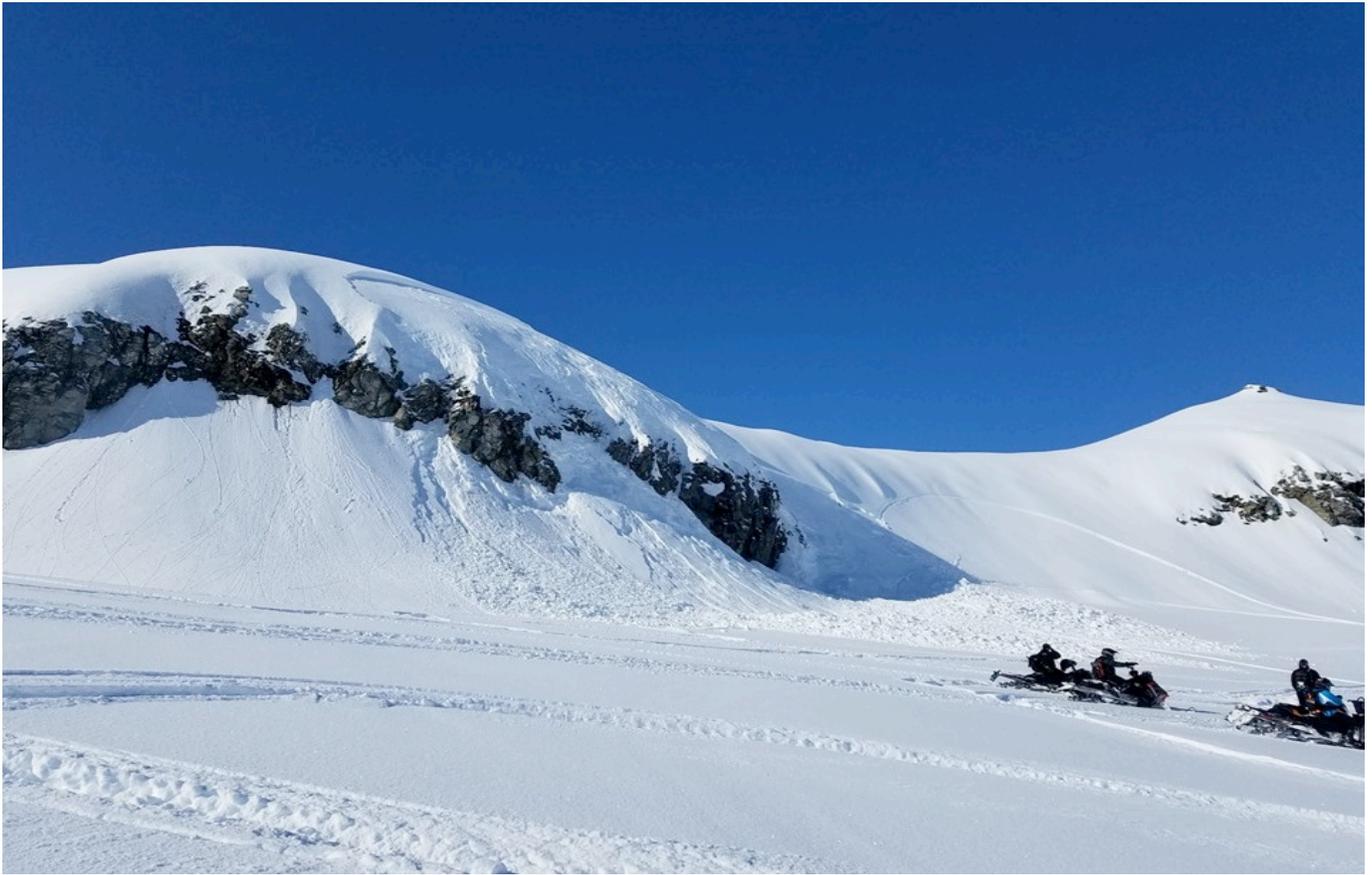
Figure 4: Photograph of a human triggered avalanche on the same day on a similar aspect.

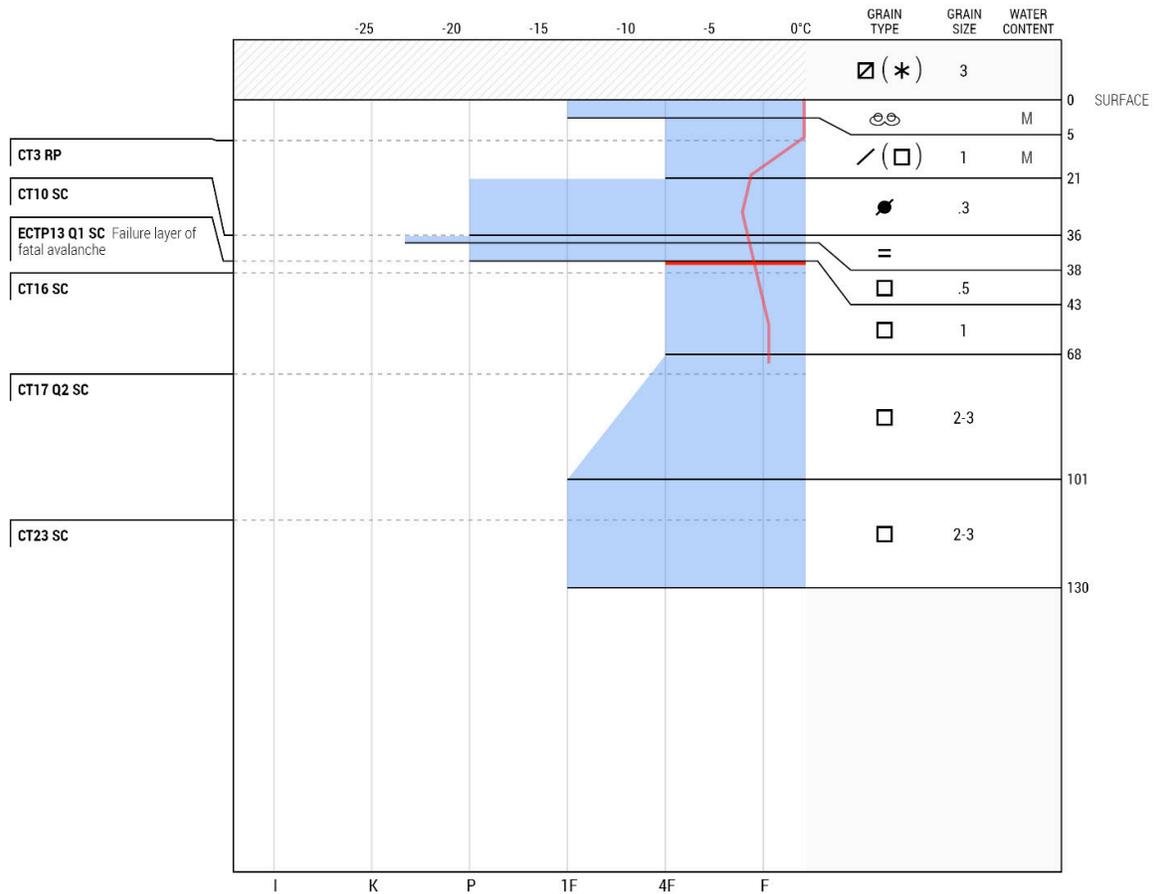
Fracture profile was not possible due to dangerous slope. We inspected the edge of the crown to verify weak layer depth, type, and HS. We then dug this pit in a safer area 700ft below the crown on an adjacent slope of the same aspect. Snowpack was nearly identical to that at the crown. Observers were Erik Stevens, Kevin Salys, and Sean Sullivan.

Figure 5: Profile of edge of crown from 2 days after accident
